# Gamma-ray computed tomography to evaluate changes in the structure of a clayey soil due to agricultural traffic

**ABSTRACT.** A first generation gamma-ray computed tomography (CT) equipped with a  $^{137}\text{Cs}$  source was used to investigate changes in soil structure due to agricultural machinery traffic. Core samples with volume of  $55\text{ cm}^3$  were collected at the surface (0-10 cm) of a Brazilian clayey soil. Significant alterations in soil structure occurred after two passages of tractor wheels, with important decreases in soil porosity. CT data allowed a continuous analysis of soil bulk density and also soil porosity distribution for 1.25 and 1.20 mm layers, which cannot be provided by traditional methods commonly used in soil physics.

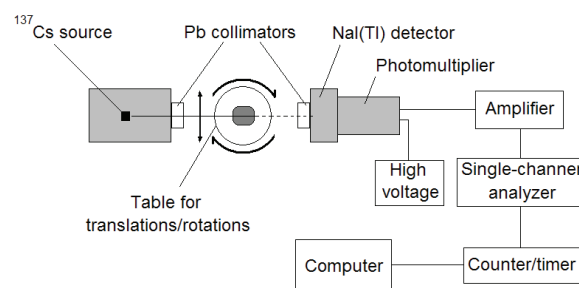
**Figure 2.** Schematic diagram of the first generation gamma-ray computed tomography (CT) scanner.

The CT scanner used was a first-generation system with a fixed source-detector arrangement and translation/rotational movements of samples

(Figure 2). Gamma-rays (661.6 keV) were emitted by a 7.4 GBq <sup>137</sup>Cs radioactive source. Circular lead collimators (1 mm) were adjusted between the source and the detector. A crystal scintillator detector of NaI(Tl) (7.62 x 7.62 cm) coupled to a photomultiplier tube was used to detect the gamma-monoenergetic photons. Samples were rotated over 180° at 2.25° steps; the linear movement steps were 0.14 cm. The voxel size was 1.14 x 1.14 x 1.00 mm<sup>3</sup> (as calculated from the ratio of the diameter of the soil sample to the number of pixels of the reconstruction matrix and the diameter of the gamma-ray beam). The acquired data were stored on a PC and the reconstruction algorithm Microvis (2000), developed by Embrapa Agricultural Instrumentation (CNPDIA – São Carlos, Brazil), was used to obtain the CT images. The calibration of the CT scanner was obtained through the correlation between linear attenuation coefficients  $\mu$  (cm<sup>-1</sup>) of different homogeneous materials (water, nylon, acrylic, alcohol, aluminum and brass) and their respective tomographic units (TUs) obtained by the image reconstruction program.

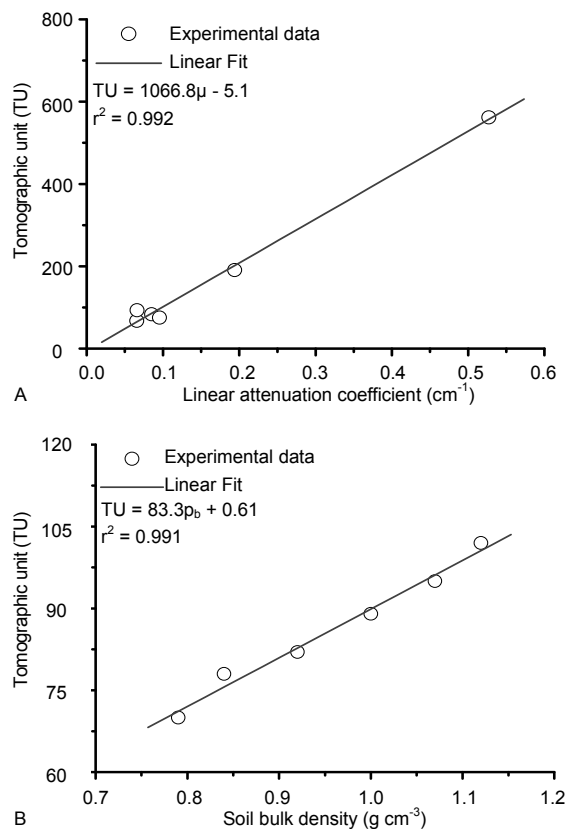
**Figure 3.** (A) Calibration curve between the tomographic units (TUs) and linear attenuation coefficients ( $\mu$ ) of different materials for  $^{137}\text{Cs}$  gamma-photons and (B) TUs versus soil bulk density ( $\rho_b$ ) of samples with different compaction states.

A good linear correlation between the tomographic units and the linear attenuation coefficients of different materials (Figure 3A) was obtained, which is essential to obtain quality CT images (CRESTANA et al., 1985). Soil and water mass attenuation coefficients, for the 661.6 keV photons, were  $0.0836 \pm 0.0007$  and  $0.0823 \pm 0.0008 \text{ cm}^2 \text{g}^{-1}$ , respectively. TU increases linearly with dry  $\rho_b$  (Figure 3B), showing a linear dependence for different soil compaction states and bulk density (VAZ et al., 1989).

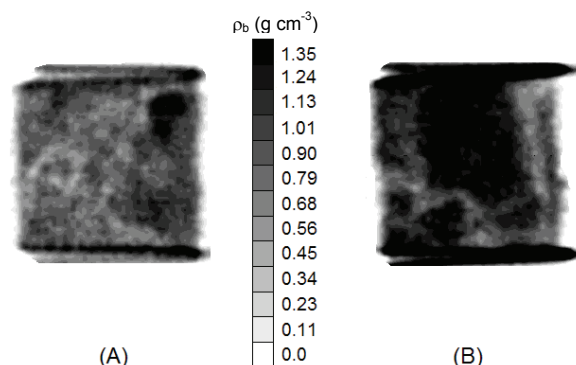
**Figure 4.** 2-D tomographic images of core samples used for evaluating the effect of passages of tractor wheels on the structure of a Brazilian clayey soil. (A) Sample not submitted to passages of tractor wheels, and (B) sample submitted to two-wheel tractor passages. The scale represents the soil bulk density ( $\rho_b$ ) distribution.

From the 2-D images taken through the gamma-ray CT, it is possible to observe the changes in soil structure induced by the machinery traffic (Figure 4). Figure 4A presents the soil sample not submitted to passages of tractor wheels, showing the existence of several areas of lower density (white areas) and compacted regions (black areas) next to the edges, which represent the photon attenuation by the steel cylinder. However, a very compacted portion can be observed near the lower sample surface.

In Figure 4B, one can see a great increase in regions of higher  $\rho_b$  inside the soil sample, which represents a direct result of the two-wheel (2P) tractor passages. As these effects appear to cover almost the entire sample, it is likely that this tropical clayey soil is very susceptible to great changes in its soil pore system after agricultural machinery traffic. According to Pagliai et al. (2003), important damages can be induced in soil structure after passages of rubber tracked tractors, due mainly to the reduction of elongated pores following the same trend of total porosity.

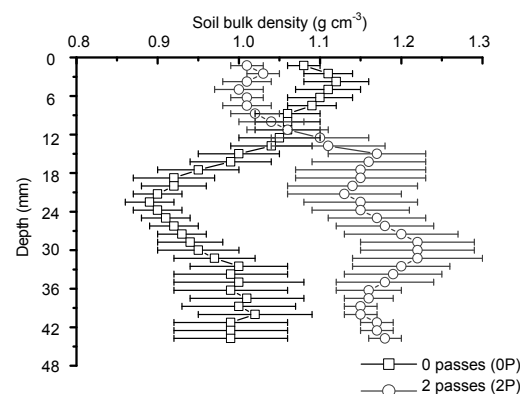
**Figure 5.** Soil bulk density ( $\rho_b$ ) variations along depth for core samples not submitted and submitted to two-wheel tractor passages. Errors bars are 95% confidence intervals.

Soil bulk density variations before (0P) and after (2P) tractor wheel traffic are shown in Figure 5. It is possible to observe up to about 10 mm in depth a more dense area for the sample 0P than 2P, which can be explained by the presence of surface crusting for 0P (PIRES et al., 2007). Samples not submitted

However, those submitted to machinery traffic were collected in a 3 to 7 cm deep layer, being the excessive soil carefully trimmed off and top and bottom surfaces of samples made flat. Below 10 mm in depth, a significant increase in  $\rho_b$  can be observed after 2P when compared to 0P (Table 1). The  $\rho_b$  increment ratio for 0P and 2P in relation to samples collected in the native forest shows a difference of 14% between these two treatments. The increment ratio of density ( $\Gamma_n$ ) parameters obtained in this study are higher than those measured by Marsili et al. (1998) also comparing 0P and 2P ( $\Gamma_n = 0.13$ ).

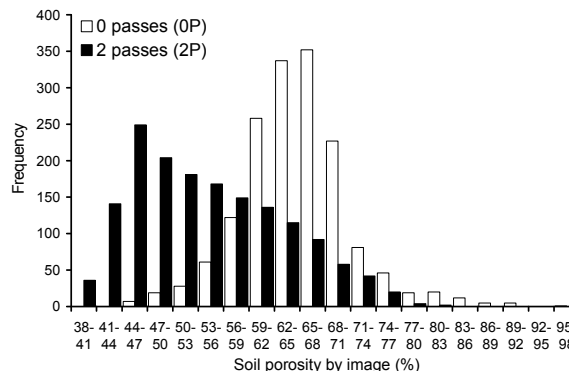
**Figure 6.** Changes in the soil porosity by image ( $\phi_i$ ) for core samples not submitted and submitted to two-wheel tractor passages. The frequency represents the number of points added in the matrix of soil bulk density ( $\rho_b$ ) used to reconstruct the 2-D tomographic images.

The increase in  $\rho_b$  after passages of tractor wheels can be explained by macropore decreases (MARSILI et al., 1998; PAGLIAI et al., 2003), once soil volume is reduced during soil surface load application by heavy vehicle traffic (Figure 6). This compaction
