EFFECTS OF LOADING ON CONCRETE QUALITY THROUGH ULTRASOUND TESTING

Elvys Dias Reis ¹

Rodrigo Moysés Costa ²

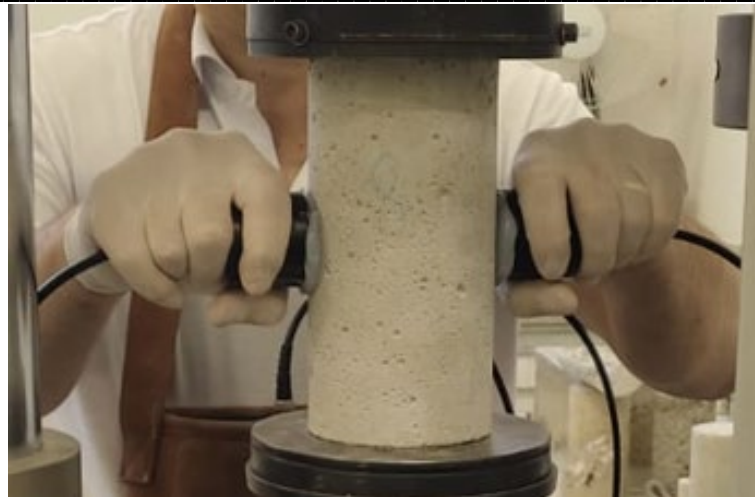
Figure 1. Measurement of UPV in the radial direction of the specimen

(ii) ultrasonic pulse velocity: UPV was measured in two orientations. Initially, five specimens were used to determine the UPV in the direction of the cylinder height (ABNT, 2019), using a Proceq brand device (Pundit Lab(+) model) for measurements. Then, another five specimens were used to measure the UPV in the radial direction during the application of the load in the same hydraulic press as the compression test, as illustrated in Figure 1. The loading was interrupted every 30 kN of force (approximately) to measure UPV safely and then restart. This process was repeated until rupture when the last reading was taken.

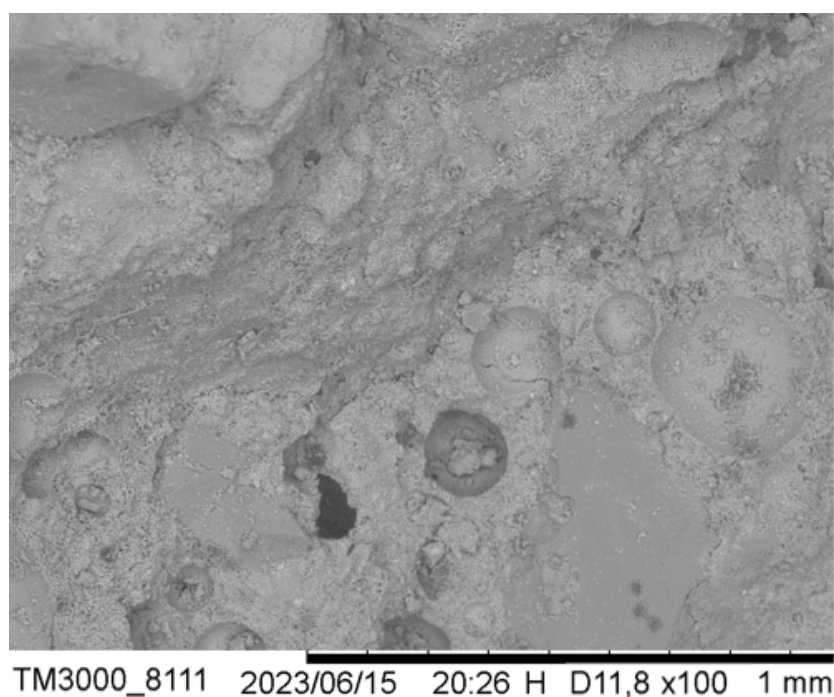
Figure 3 shows an SEM image at 100x magnification. The concrete is porous and has many macropores, negatively interfering with UPV. In other words, when flaws and/or voids exist, the ultrasonic pulse must go around them, taking more time to travel through the material.

Figure 3. SEM image with 100x magnification of the broken concrete sample

Based on the results (UP = 3716.20 m/s), it was possible to determine the quality of the low-strength concrete ($f_c = 17.48$ MPa, $f_{ct} = 1.65$ MPa) as "good". This judgment was influenced by several factors, including the high porosity (P = 6.73%) and the marked presence of macropores, verified via SEM. However, as the compression load increased, the curve fitting the data ($R^2 = 79.42\%$) indicated a decrease in UPV in the radial direction, which compromised the quality of the concrete.

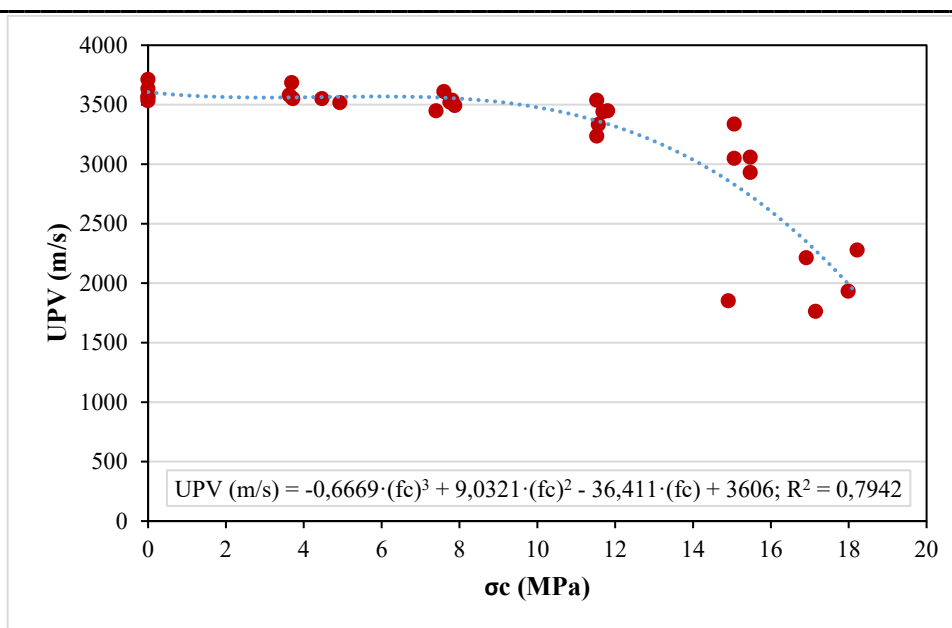
It must also be considered that the internal structure of the concrete can undergo changes resulting from external loads, altering its quality in different directions. Therefore, UPV measurements were also carried out in the radial direction of the cylindrical specimens during the compression test, with the results given as a function of the stress applied from the decompressed state (zero force) until after rupture (maximum f_c) (Figure 4).

Figure 4. Evolution of the UPV during the compression test

It can be seen in Figure 4 that the curve fitted to the experimental data presented a coefficient of determination (R^2) of 79.42%, indicating a considerable adjustment. Therefore, it is inferred that it satisfactorily explains the reduction in UPV with the increase in compressive stress (σ_c). From the results in this figure, it is also noted that the quality of the concrete is classified as “doubtful” (between 3,000 and 3,500 m/s) after 7 MPa of compression, as “poor” (between 2,000 and 3,000 m/s) between 16 MPa and 18 MPa and as “very poor” (less than 2,000 m/s) from approximately 18 MPa (IAEA, 2002).

Due to the Poisson effect, the axially compressed specimen (in its height direction) tends to elongate transversely (in this case, in the radius direction), which also occurs with its internal structure, especially in the weakest phases of the structure (interfacial transition zone and paste). Consequently, the rounded pores tend to elongate in the unconfined (radial) direction, increasing the time and distance to be covered by the ultrasonic pulse in the cylindrical specimen.
