## Structural behavior of reinforced concrete beams strengthened with bamboo splints

**ABSTRACT.** The aim of this paper is to evaluate through bending tests the structural behavior of reinforced concrete beams additionally reinforced with bamboo splints coated with rubber latex. The bamboo splints are prepared from the stems of the *Bambusa vulgaris* species and are reinforced in the nodal regions. To examine the strength of adhesion between the bamboo splint and concrete, pull out tests are performed for the specimens. The results of the pullout tests of the test samples show the strengthening of the nodes leading to an increase in the normal tension and rupture of the splint instead of its slip. According to the results of the bending beams, the presence of bamboo splints increases their load capacity when compared with the reference beams. This fact indicates a reduction in the amount of steel required as the structural element. Strengthening the nodes of the bamboo splints provides better performance in terms of deflection and also leads to a slight increase in the beams load capacity. It is worth mentioning that the beams additionally reinforced with bamboo splints reinforce

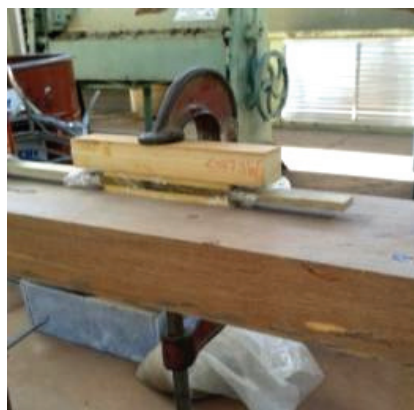
**Figure 1.** Details of the reinforcement of the splints.

All the nodes of five of the splints were reinforced in order to improve their resistance in the nodal regions, considering that part of the bamboo has a much lower resistance in comparison with the intermodal region, based on Mesquita et al. (2006) and Braga Filho, Lima Júnior, Barbosa, and Willrich (2010). The nodes of the remaining five splints were not reinforced for comparative purposes. A castor oil-based bicomponent polyurethane resin (the components of the castor oil resin were blended in a 1:1 mass ratio) was the glue applied to cast the reinforcements with a sergeant, a base beam, and supports. The latter was positioned between the sergeant and the splint so they did not get crushed (Figure 1).

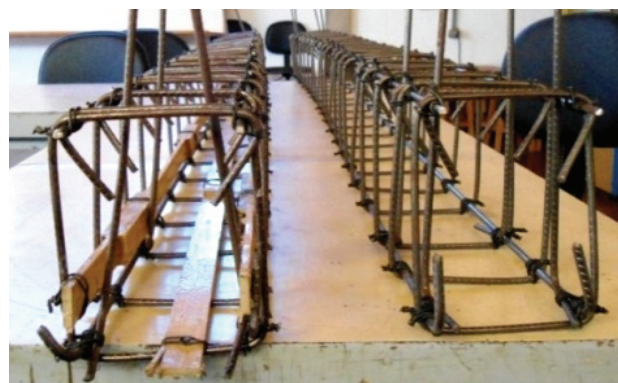
**Figure 4.** Reinforcements with (left) and without (right) additional reinforcement of bamboo splints.

For the additional reinforcement of the steel reinforced beams with bamboo splints, three splints were placed, one along the underside (centralized between the lower bars) and two along the lateral sides. The splints placed along the lateral sides were fixed at a distance of 1.5 cm relative to the bottom bar so that there were no problems during concreting (Figure 4).

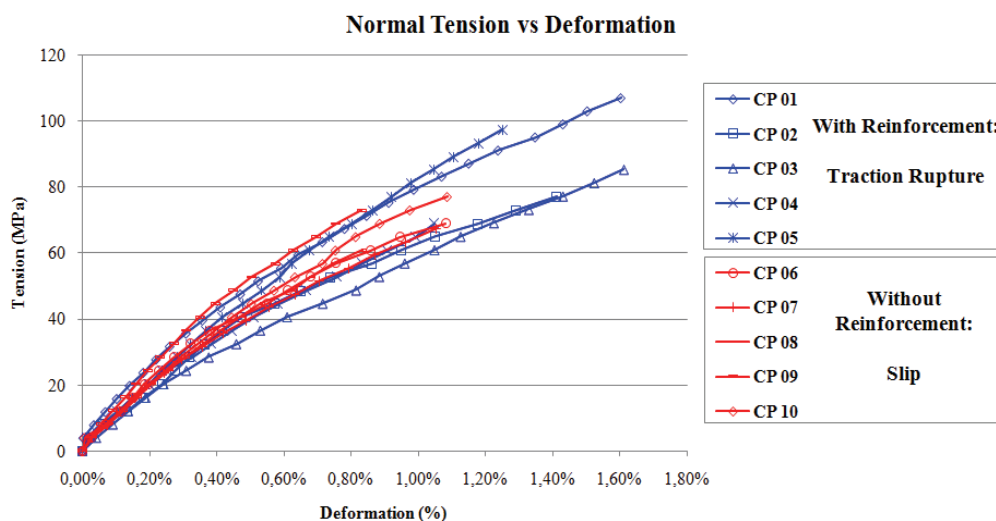
Figure 7. Pullout test: normal tension.

The normal tension and adhesion stress graphs corresponding to the pullout tests are shown in Figure 7 and 8, respectively. The mean values of the normal stresses at the time of rupture (or slip) of the specimens with and without internal reinforcement of the bamboo splint nodes were 97 and 76.5 MPa, respectively, i.e., reinforcement of the internal nodes resulted in an increase of 28% of the normal stress. Mesquita et al. (2006), in tests with concrete specimens and bamboo splints studded with steel and bamboo pins, found that the positions of the steel and bamboo pins increased the adhesion tension by 80 and 50%, respectively. Comparing the results of the slabs with those obtained by means of a smooth steel bar, the authors verified that the steel and bamboo pins presented tensions of adhesion superior to those of smooth steel in 25 and 5%, respectively.

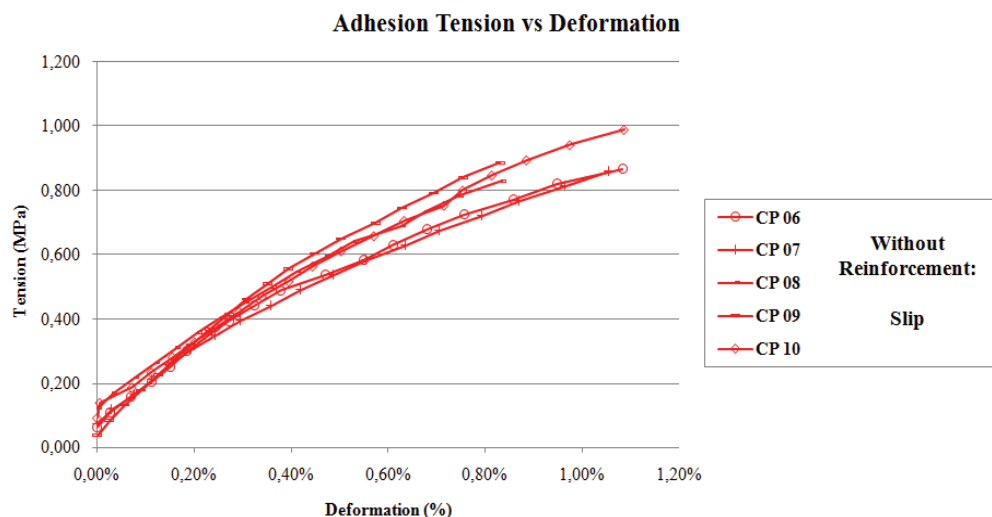
Figure 8. Pullout test: adhesion tension only for sliding specimens.

The average value of the adhesion tension at the moment of slip for the specimens without internal reinforcement of the bamboo splint nodes was 0.9 MPa. For the specimens reinforced at all the nodes, the tensile rupture was observed in the splints.

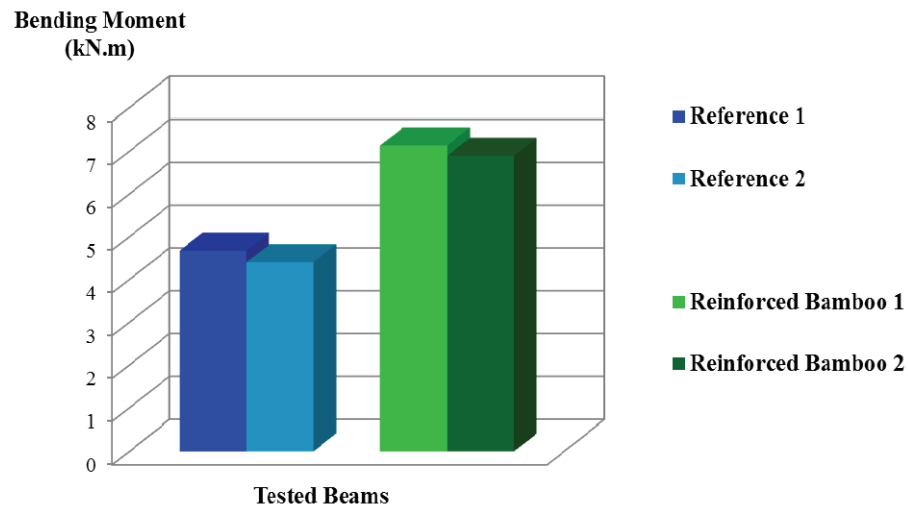
Figure 9. Comparative graph of the maximum bending moment (rupture) supported for each beam tested.

The main parameters obtained by the beam bending tests are presented in Figure 9 at 12.

The results obtained show that the additional reinforcement with bamboo splints waterproofed with latex and reinforced at the nodes causes a 58% increase in the resistance of the beam, suggesting that it can support a greater load than in the absence of the additional reinforcement. Ghavami (2005) carried out tests on beams with and without steel reinforcement using two percentages of bamboo frame in relation to the cross section of the beam (3.33 and 5%) and it was verified that the ideal amount to be used as reinforcement of beams is a 3% bamboo rate in relation to the concrete cross section. It was also verified that bamboo-reinforced beams supported a load 400% greater than the beams without any reinforcement. Agarwal, Nanda, and Maity (2014) performed bending tests on reinforced beams, reinforced with steel, reinforced with treated bamboo and reinforced with untreated bamboo. The results of the bending tests showed that the beams reinforced with treated bamboo obtained a significant increase in the rupture force when compared to the steel beams. Quantitatively, with a treated bamboo reinforcement of only 1.5% there was an increase of 29% in the resistant capacity.

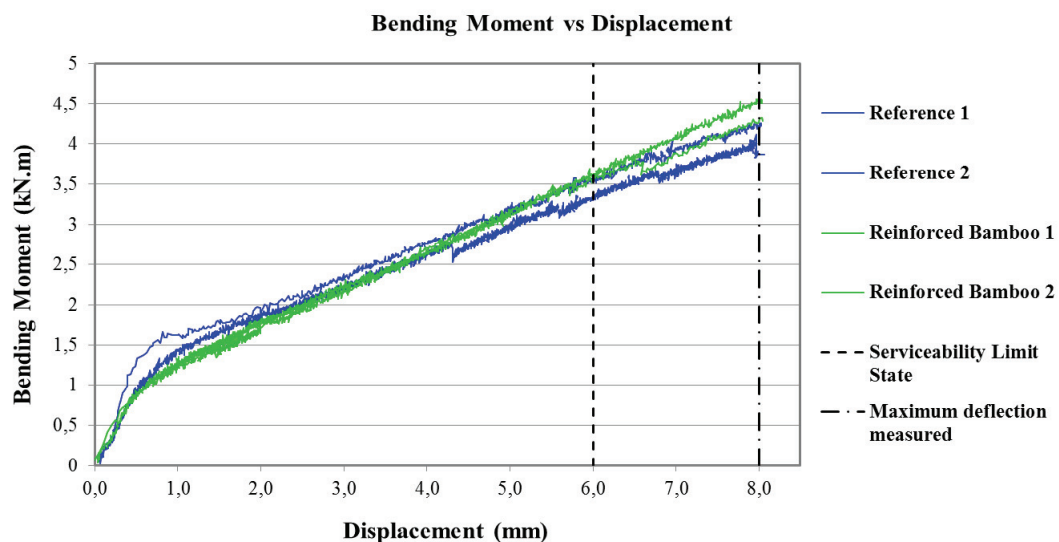
Figure 11. Comparative graph of the variation of bending moment versus displacement (or deflection) of all the beams tested.

With respect to the moment corresponding to a deflection of 6 mm in the middle of the beam (Serviceability Limit State), the presence of the reinforcement results in an increase of 7.1%. This suggests that the Serviceability Limit State would be reached first for the reference beam and only then for the reinforced bamboo beam. For a deflection of 8 mm, it is observed that the additional reinforcement provided by the bamboo splints with reinforcement at the nodes causes an increase of 10.5%.

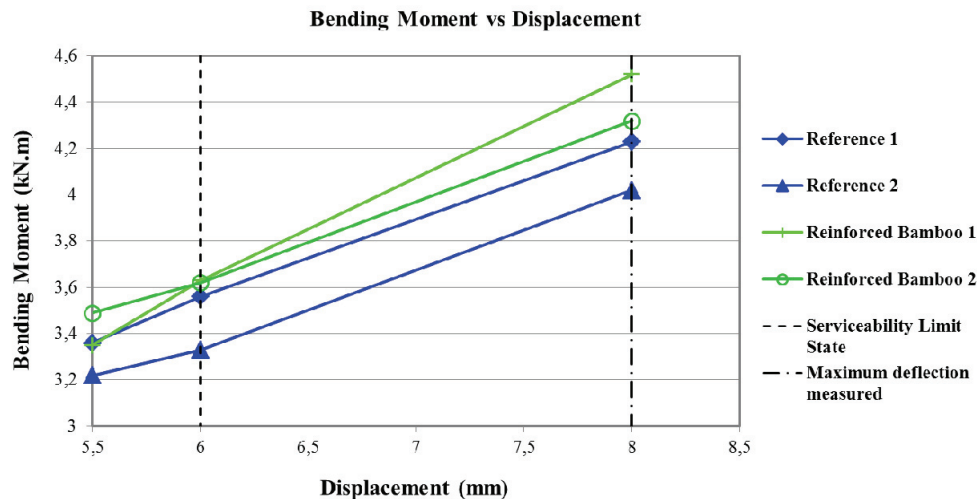
**Figure 12.** Comparative graph of the variation of the bending moment versus displacement (or deflection) of all the beams tested between 6 and 8 mm deflections.

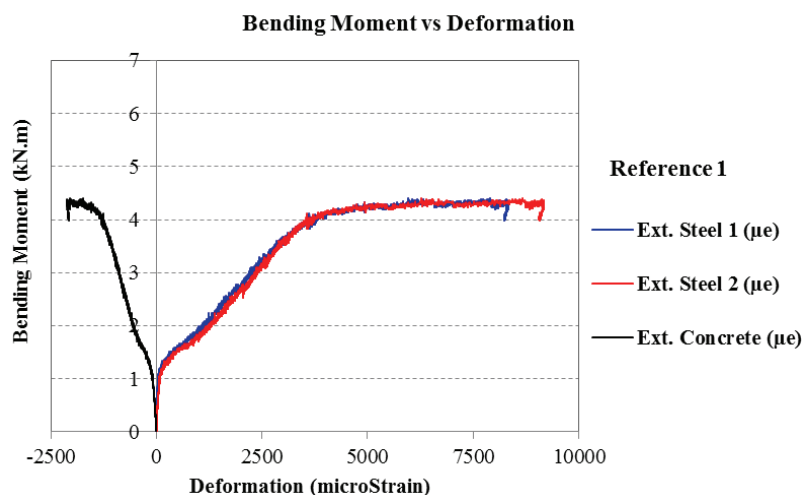
**Figure 13.** Data from the extensometers positioned in reference beam 1.

The deformations in the concrete, the lower longitudinal reinforcement, and the bamboo splints were evaluated using extensometers positioned in the middle of the beam. Figure 13 and 14 present the data obtained through the extensometers present in the reference and reinforced bamboo beams, respectively.

In the case of reference beam 1, for the traction reinforcement in the situation corresponding to the last bending moment, a typical flow level is observed with deformations above 8 per thousand.

The concrete exhibits a linear behavior and only near the rupture there is a sudden elevation of the neutral line and, consequently, there is a reduction in the compressed concrete area and in its crushing. Before the crushing began, the deformation in the concrete was 1.25 per thousand.

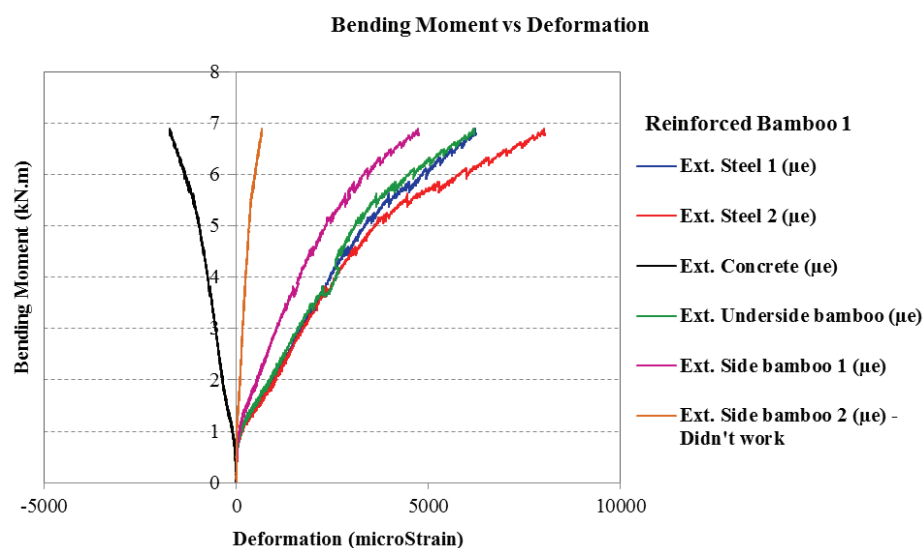
**Figure 14.** Data from the extensometers fixed in reinforced bamboo beam 1.

For the reinforced bamboo beam 1, the deformation in the concrete is 1.73 per thousand. For the steel beam, however, it is above 6.25 per thousand, which almost coincides with the deformation of the bamboo positioned on the underside of the beam, which shows that the bamboo was well adhered to the concrete.

The lateral bamboo undergoes a deformation of 4.75 per thousand, a value that is coherent as the position of its center of gravity is above the lower bamboo (and steel).

Thus, owing to the fact that the bamboo absorbs part of the tensile stress, the deformation in the steel might be smaller. For reinforcement, a well-defined flow threshold is not observed as in reference beam 1. However, plastification starts. Furthermore, the crushing of the concrete resulting from the ascent of the neutral line is observed, with deformation in the concrete that is larger than that of reference beam 1. That is due to the resulting increase in strength of the compressed concrete to balance the resultant tensile provided by the steel reinforcement and the bamboo.
